DCS Home Inspections

Oklahoma General Home Inspection Report

Property address: XXXXXXXXX, OK

Inspection date: XXXXXXX

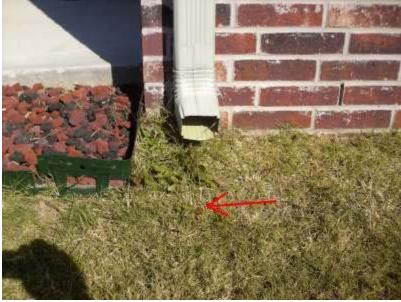
Photo 4

1) Repair/Replace - One or more downspouts have no extensions. This can result in water accumulating around the structure's foundation. Accumulated water is a conducive condition to wood destroying insects and organisms, and may also cause the foundation to settle over time. Repairs should be made as necessary, such as installing or repositioning splash blocks so rain water is carried at least several feet away from the structure to soil that slopes down and away from the structure.

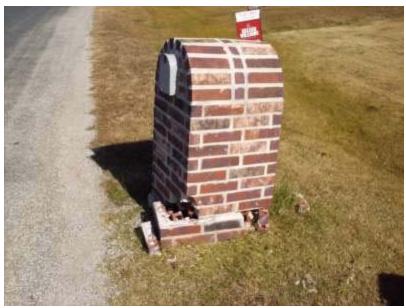
Photo 3

2) Repair/Replace - The brick mailbox is damaged and could fall, This is a possible safety hazard and should be repaired or replaced.

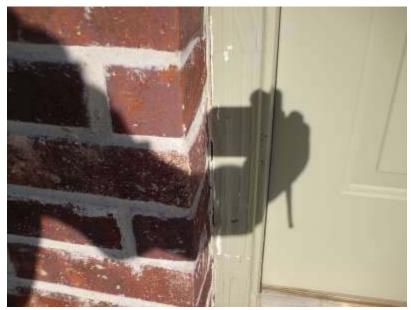
Photo 7

3) *Minor defect, Maintain* - Caulk is missing or deteriorated on the side garage door and at the bottom of the overhead garage doors, it should be replaced and/or applied where necessary. For more information on caulking, visit <u>The Ins and Outs of Caulking</u>.

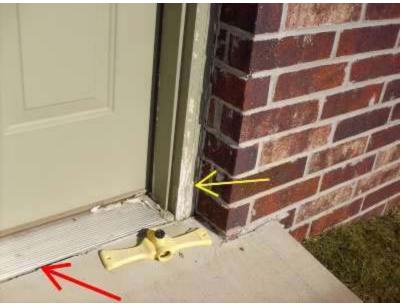
Photo 8

4) *Minor defect, Maintain* - The exterior finish on the side garage door is in need of repair. Prep (scrape, sand, prime caulk, etc.) and repaint areas as needed and as per standard building practices.

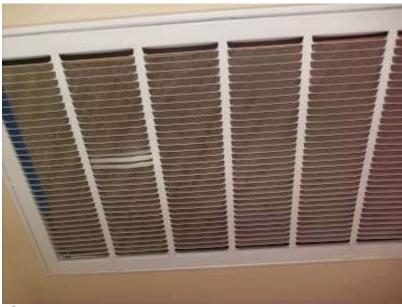
Photo 5

10) Minor defect, Maintain - The air handler filter is dirty and should be replaced on a regular basis.

Dirty filters can cause the unit to run inefficiently.

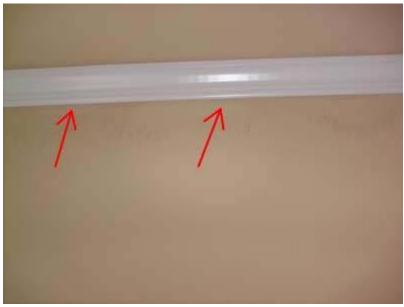
Photo 6

15) *Minor defect, Comment* - Stains were noted in front bedroom at ceiling-wall junction. This indicates a past leak, No signs of a current leak are present. (No mold or dampness exist)

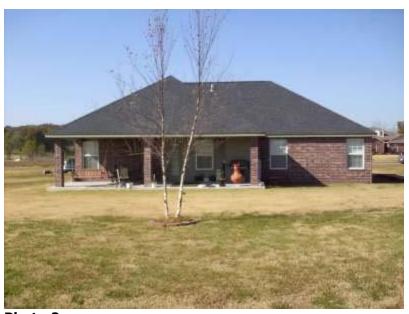
Photo 2

16) *Maintain, Comment* - This home was well built . Quality materials and construction practices appear to have been incorporated throughout.
